Manhole Inspection Summary

Manhole # S07YY1006MH

Insp Date: **9/14/06 9:13 AM**

Location Address: **2916 GLEN AVE**

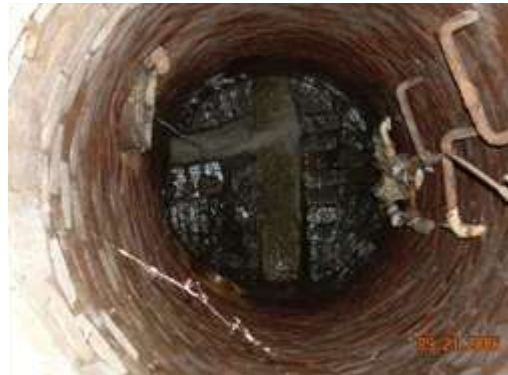
Top View

Condition: ☐ Sound ☐ Cracked ☐ Root Intrusion ☐ Loose Brick ☒ **Deteriorated**

Infiltration: ☐ None ☒ **Joint** ☐ Cracks ☒ **Mortar** ☐ Roots ☐ Wall

Adjustment deterioration and infiltration.
Bench debris. Corroded steps.

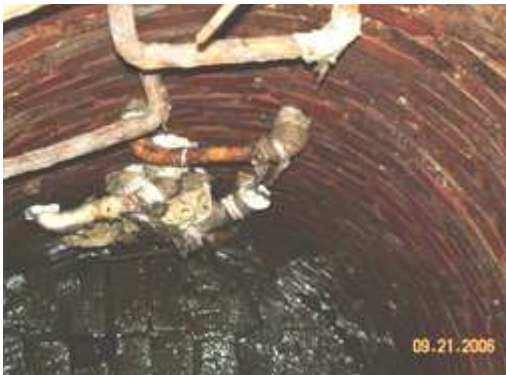
Defect

Condition: ☐ Sound ☐ Cracked ☒ **Root Intrusion** ☐ Loose Brick ☒ **Deteriorated**

Infiltration: ☐ None ☐ Joint ☐ Cracks ☒ **Mortar** ☒ **Roots** ☒ **Wall**

Barrel infiltration. Evidence of surcharge -
Bench debris.

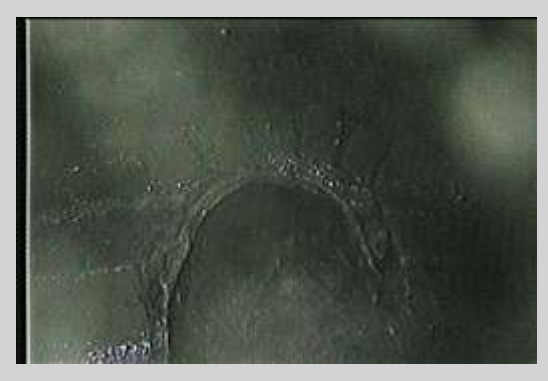
12 in. Circular Gravity Sewer Pipe Out @ 12 O'Clock

Barrel deterioration and infiltration.

Infiltration: **Evidence** Pipe Seal Cond: **Cracked**

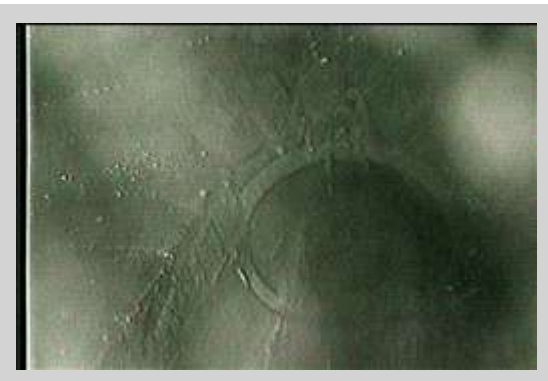
12 in. Circular Gravity Sewer Pipe In @ 6 O'Clock

Barrel deterioration, root intrusion and infiltration.

Infiltration: **None** Pipe Seal Cond: **Roots**

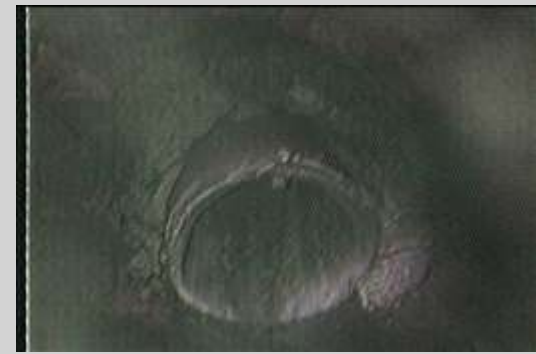
Pipe In @ 7 O'Clock

Infiltration: **Evidence** Pipe Seal Cond: **Cracked**

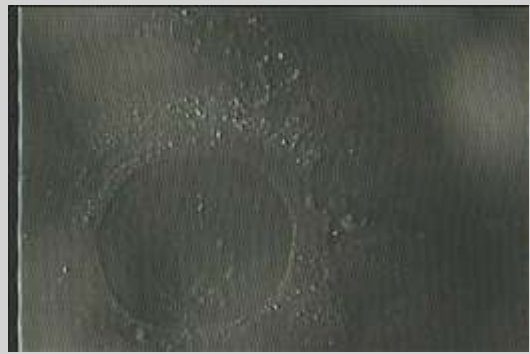
Drop In @ 7 O'Clock

Drop Condition: **Open**
